HISTORIC INFRASTRUCTURE REHABILITATION WITH FABRIC REINFORCED CEMENTITIOUS MATRIX (FRCM) COMPOSITES

Diana Arboleda, Francisco De Caso, and Antonio Nanni

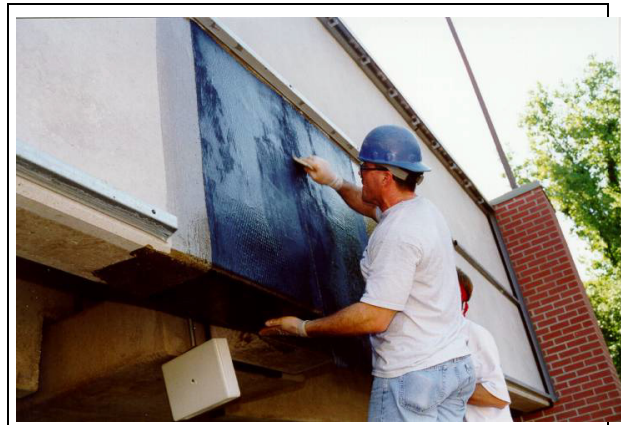
Figure 1. Typical FRP application

bonding, section enlargement, and external post-tensioning. These methods are already known and used in Cuba. The country has a strong background in engineering education and training, due in part to several university institutions (Alfonso and Penin, 2009). One of the most commonly used external repair/strengthening method is the use of FRP, which consists of applying a “skin” on the damaged structural element. This “skin” is defined as a structural fabric applied with a polymer (Figures 1 and 2); it has numerous advantages such as compatibility with the substrate, protective of the substrate, lightweight, durable, and does not require formwork.

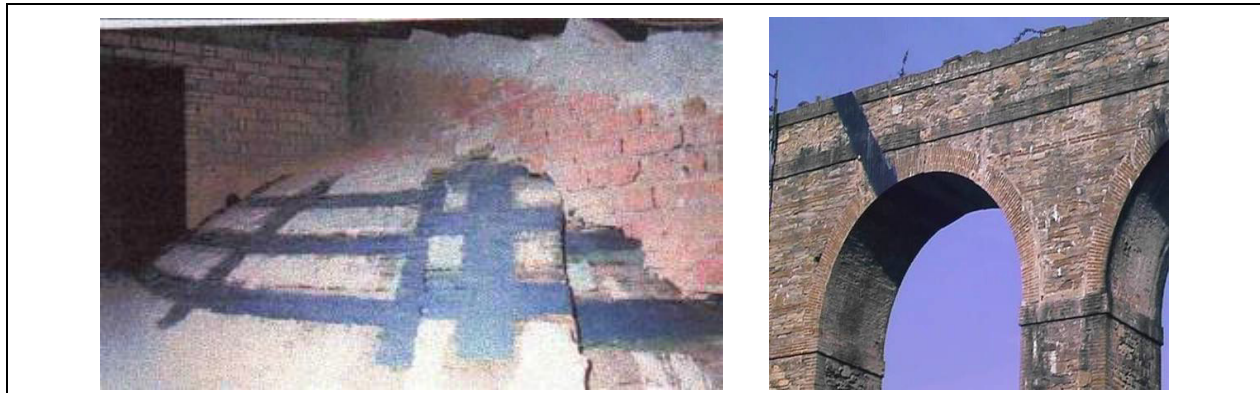
Figure 2. Examples of strengthening of historical and modern masonry with FRP

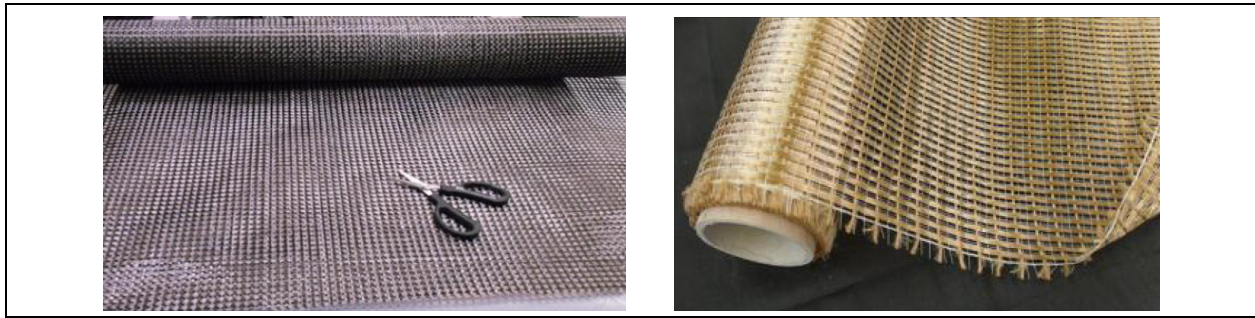
Figure 3. FRCM reinforcement fabric examples. Left: carbon fabric, right: PBO fabric

A new class of composite materials, FRCM is considered as the natural evolution of ferrocement where the steel mesh reinforcement, which is vulnerable to corrosion, is replaced with man-made and natural materials such as carbon, basalt, polyparaphenylene benzobisoxazole (PBO), hemp, flax, bamboo, or glass fiber fabrics (Figure 3).

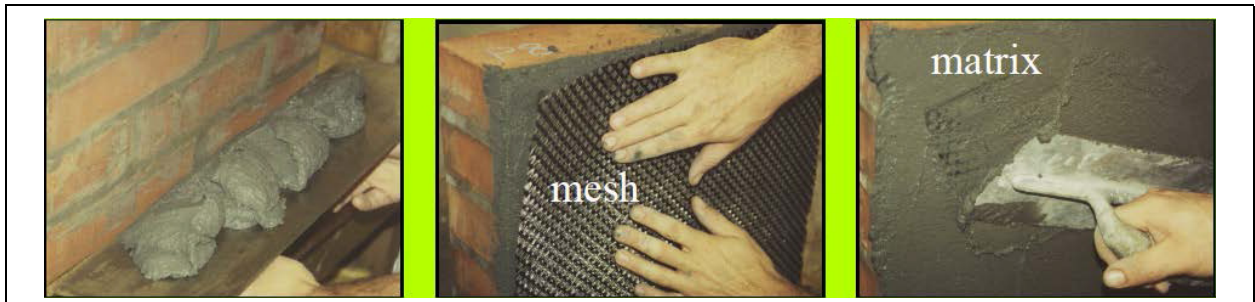
Figure 4. Application of FRCM on a masonry wall

Typical FRCM installation involves first a simple preparation of the substrate that involves removal of previous damage and cleaning to eliminate debris. Then, a thin layer of the mortar (cementitious matrix) is applied to the surface of the structural member to be strengthened manually with a trowel as in Figure 4 (left), then the fabric is applied with the primary fabric orientation in the direction of the load as in Figure 4 (center), and a finishing layer of the mortar is applied to the last fabric layer, completing the composite as in Figure 4 (right). The FRCM composite hardens within a few hours and achieves full strength at 28 days.

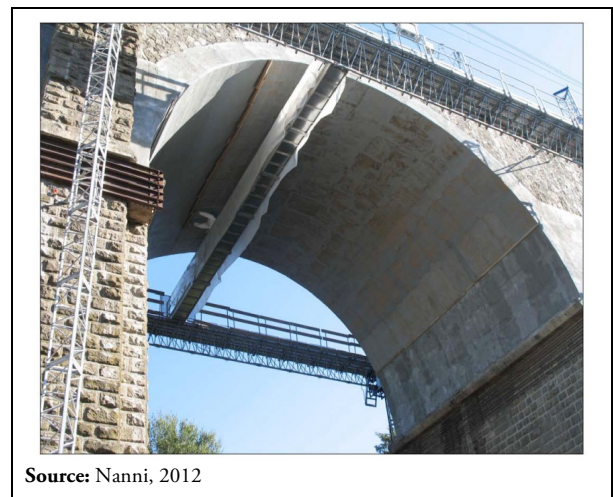
Figure 5. Repair of unreinforced concrete vault

for infrastructure strengthening. In Figure 5, a worker installs FRCM onto the soffit of an unreinforced concrete vault, then advances rolls of the fabric network. Then a second fabric layer is installed over the first layer. Figure 6 shows how rolls of the fabric network hang from the vault as the scaffolding is advanced (Nanni, 2012).

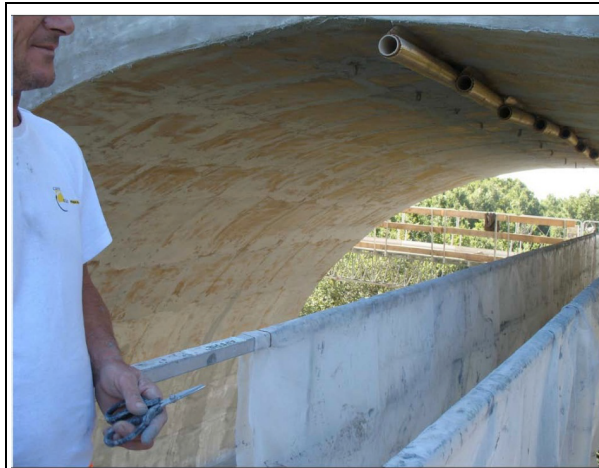
Figure 6. Rolls of fabric hang while scaffolding is advanced.

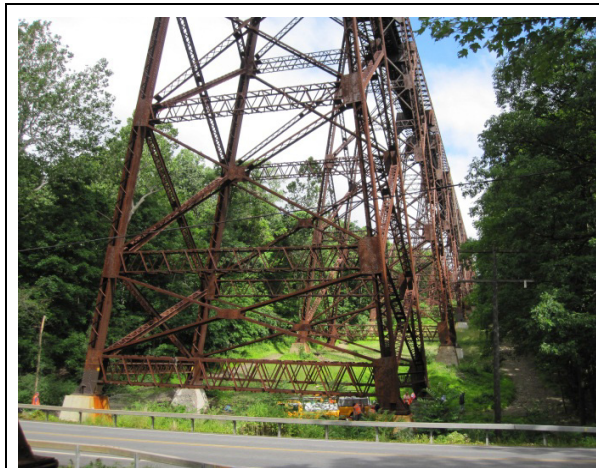
Figure 7. Structural steel trestle supported by trapezoidal concrete pedestals

Figure 7 shows a structural steel trestle supported by numerous trapezoidal concrete pedestals in need of repair and in Figure 8, workers apply PBO fabric over a layer of the cementitious mortar matrix that had already been applied to one of the pedestals (Nanni, 2012).

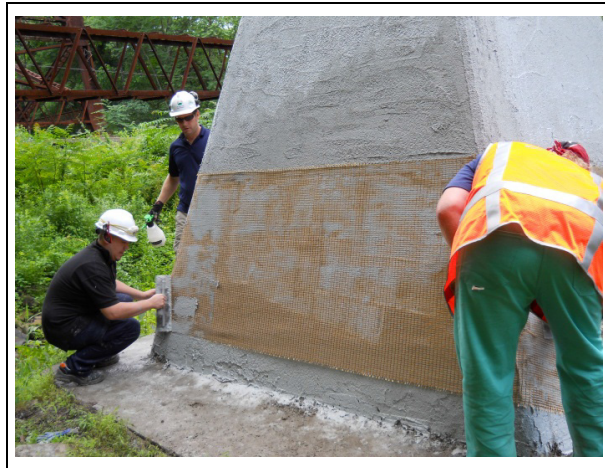
Figure 8. Application of PBO fabric over the cementitious matrix
